ONONDAGA DAM
NEW YORK
INVENTORY No. NY 794

PHASE I INSPECTION REPORT
NATIONAL DAM SAFETY PROGRAM

PHASE I INSPECTION REPORT
ONONDAGA DAM I.D. NO NY 794
OSWEGO RIVER BASIN
ONONDAGA COUNTY, NEW YORK

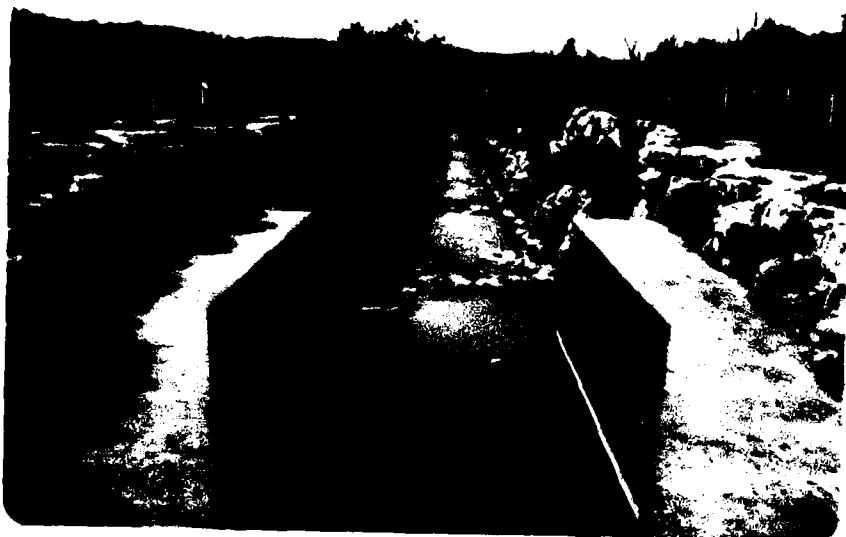
10. Reservoir drain
outlet channel,
looking downstream.
